Old Pain, New Pain, Hot Pain and Cold Pain

By Yin Lo, PhD

Editor's note: The photos in this article are taken from chapter 3 of Dr. Lo's forthcoming book, *Acupuncture: Quantum and Supreme Health*.

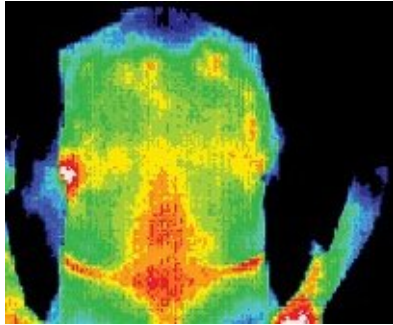
Infrared image of patient after treatment by acupuncture. Image of patient after treatment by acupuncture.

Image of patient before treatment by acupuncture. The color code for both photos is as follows: white is the hottest followed by red, yellow, green, blue and black.

This patient was a woman in her 40s who complained of lower back pain. The thermal image of her back (below) revealed three problem areas. The posterior neck area was cold (shown as blue in the uppermost

section of the photo). The left middle back had a hot area (shown as a white spot), as did the spinal cord area on the lower back (shown in red). Upon questioning, the patient confirmed a longstanding problem in her neck, which came and went periodically. She was involved in an automobile accident two years ago, which caused a lump on the left middle back. Acupuncture was administered; massage and moxibustion were applied to the neck region.

After treatment, the patient's symptoms were reduced considerably on these problem areas. The cold blue area of the neck became warm and red. The hot white spot on the left middle back disappeared, and the hot red area of the back became colder. Repeated treatments were recommended to cure all of these areas.

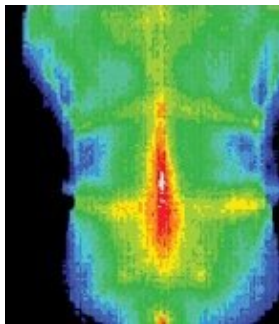
Patient before treatment. Temperature color code same as previous series of photographs.

We found that although she complained of right leg, the origin of her pain was around the spinal cord. The doctor treated her with electroacupuncture at a frequency of 2 Hz. After a 20-minute session, the area showed great improvement (see below). The maximum temperature dropped from 39.4 C to 37.17 C, a decrease of 2.23 C, and the pain subsided.

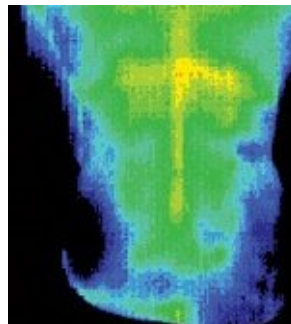
Patient after being treated with electroacupuncture.
